## Static seals may not be static

Edited by **Alan L. Hitchcox**

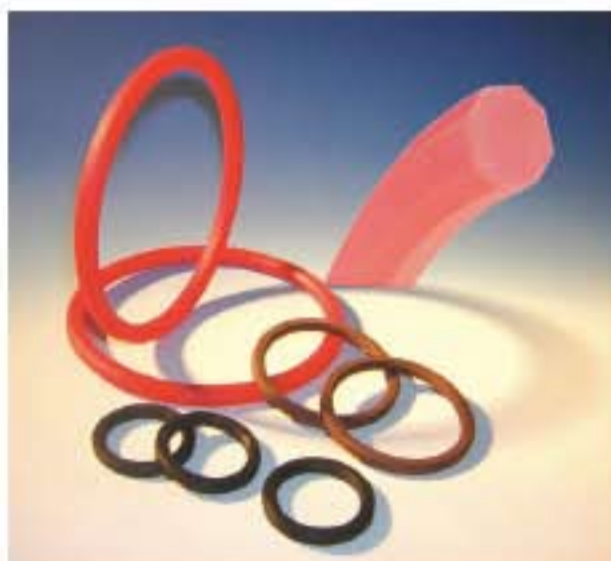
**The Octi-ring was specifically designed to combat the effects of the high-speed small strokes that a standard issue O-ring is incapable of handling.**

Solving the challenge of end-cap O-ring failure prompted American High Performance Seals, Oakdale, Pa., to develop the Octi-ring, an eight-sided version of an O-ring. The corners of the Octi-ring have smooth surface finish chamfers to combat the effects of the high-speed, short strokes that standard O-rings cannot. These chamfers are precisely calculated and tightly controlled

by manufacturing them on a CNC lathe to ensure that the seal remains tight without exhibiting fatigue damage.
